**THE
HISTORIC
HUNTSVILLE**

January-March 1978

Uncovering A Furn Of The Century Beauty

By Kay Blair

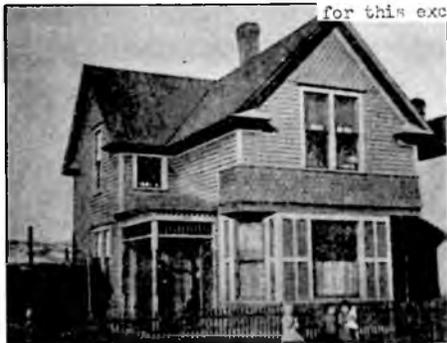
The house, right after completion, in 1900.

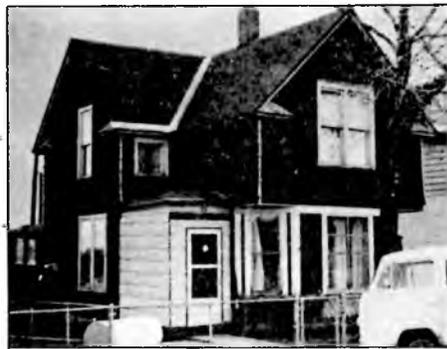
As it looked when the Blairs bought it.

AFTER LIVING IN and running a Victorian restoration (museum) for five years, my husband and I decided to buy a piece of Victoriana for our own. The house we bought was covered with asbestos siding, the roof was shingle underneath with asbestos over it (and in need of repair) and the attractive old porch had been enclosed. However, we were fortunate in having a photograph of the house we purchased that had been taken at the turn of the century.

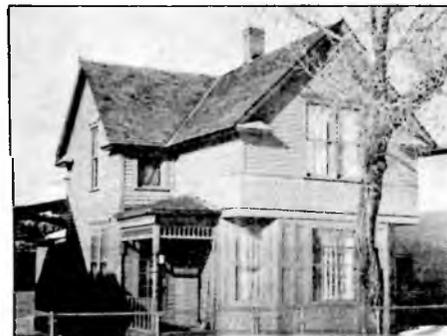
The restored house is painted dark gold with blue trim to articulate its features.

FROM OUR PAINT SCRAPINGS we determined that the house had been shades of green, then yellows and brown. It had been a three color paint job originally, but we felt that two colors were all we could handle and we chose a dark blue trim and dark earthy gold for the main color to give the house a lot of color and warmth against the annual two hundred inches of snow we receive that is on the ground at least eight months of the year. We used Sherwin Williams latex and we did not use a base coat since the old paint job was in good shape for the most part and we did not use a primer on the new wood or scraped and sanded areas and so far we have had no problems with the paint. We did caulk seams and fill the nail holes from the asbestos siding with a latex caulking compound. And we washed the house before painting.

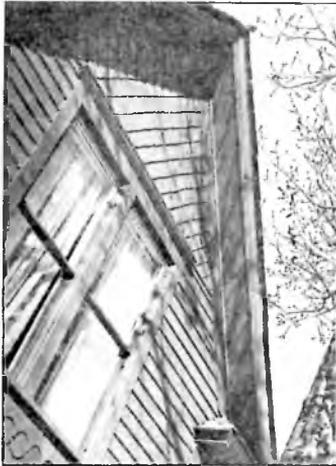
Original cap moulding left over second storey window.

WHEN THE ROOFING WAS COMPLETED, my husband joined me in the painting project and we began to attend to some of the problem areas. The cap mouldings over the windows and the mouldings under the eaves had been removed when the asbestos was put on. We were very fortunate to have the photo to show us what had been where and one cap moulding had been left over the front second storey windows. With the picture to guide us and the example left, we set about to construct our own detail work for replacement.

THE CAP MOULDINGS over the windows were not as easy. We used four pieces of lumber; one was a wide flat board approximately 5 in. in width, then nailed to the top of it is a piece of milled window or door framing (interior) approximately 3 in. in width, and placed a piece of cap wood on top. The fourth board was a piece of lath that we placed behind the assembled cap moulding to force it slightly forward from the wall. The cap mouldings were cut at 45 degree angles on each end. This gave them the same appearance as the old cap moulding. These, too, were constructed and painted before attaching them above the window.

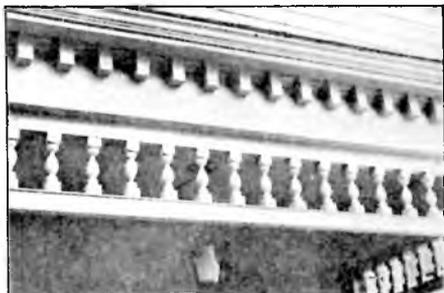
Detail of spindles used to restore porch.

THE ORIGINAL SPINDLES were thinner in diameter than those on the market today, but we knew to be exact the spindles would have to be contracted for and such a specialty in our area is impossible to find. So, we used 6 in. spindles available in lumber yards and some discount stores. There were markings on the remaining support posts that showed us where the supportive wooden pieces had been and their size. We used 1½" x 2½" strips of wood on top and bottom and placed the spindles 3 in. apart. We built two separate units, one for the front of the porch, the other for the side. We built each unit and painted it, then nailed it into place. The original porch did not have a handrail or spindles on the side, but was open instead.

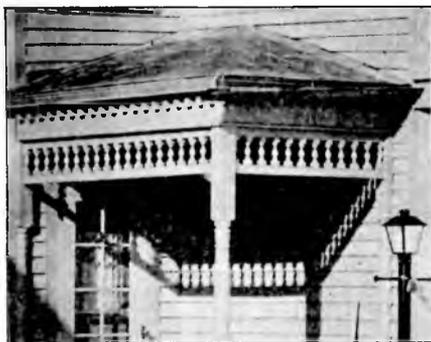
Porch after restoration was completed.

THIS LEFT AN UNBALANCED look so we purchased a readymade handrail (available at lumber stores) and 28 in. height balusters and put in our handrail. There were other old houses around town that had similar rails original to their porches, so it was historically in keeping with our area to do this.
